# Manhole Inspection Summary

Manhole # S31KK\_009MH

Insp Date: **7/2/07 12:03 PM**

**Location** Address: **1901 FALLS RD**

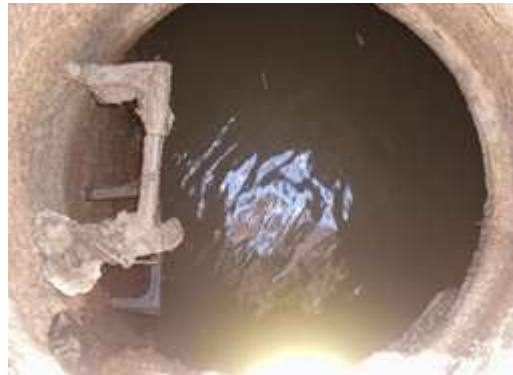
Top View

☒ **Debris** (not Condition related)

☒ **Evidence Of Surcharge**

Depth: **3** (ft.) ☐ Active Surcharge Present

Evidence of surcharge - Bench debris.

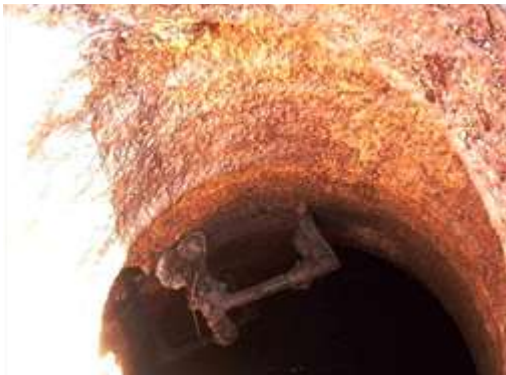
Defect

☒ **Leaks**

Infiltration: ☐ None ☒ **Joint** ☐ Cracks ☐ Mortar ☐ Roots ☒ **Wall**

Infiltration: ☐ None ☐ Joint ☐ Cracks ☐ Mortar ☐ Roots ☒ **Wall**

Frame leaks. Adjustment and Corbel infiltration.

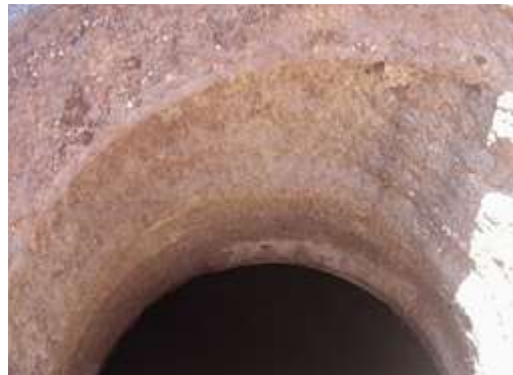
Defect

Frame leaks. Adjustment infiltration.
